# Complex Hi-Pressure Gas Line intervention successfully executed with new design 1500 class 4" AOGV avoiding outage and hot work for new customer.

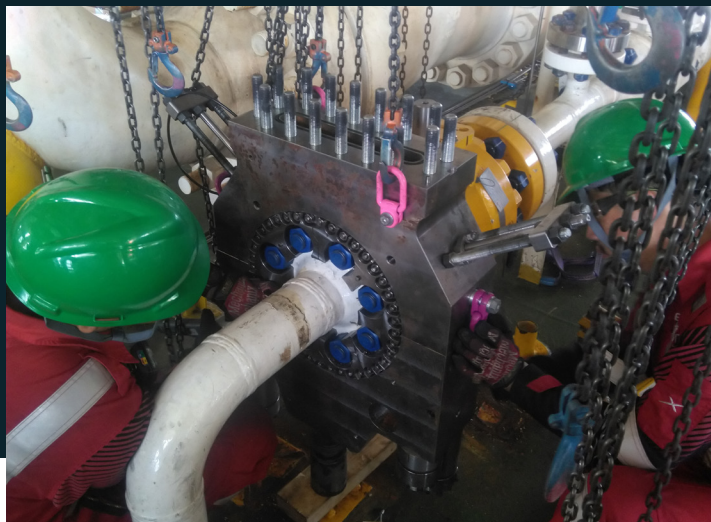
With no site survey performed, Izomax worked closely with the client and the main platform contractor to confirm accessibility. As seen from the image above, there were space limitations at the rear of the valve and spool junction (between the two capped flanges).
