# Izomax AOGV provides barrier assurance on live seawater lines allowing replacement without production shutdown on Guyana FPSO

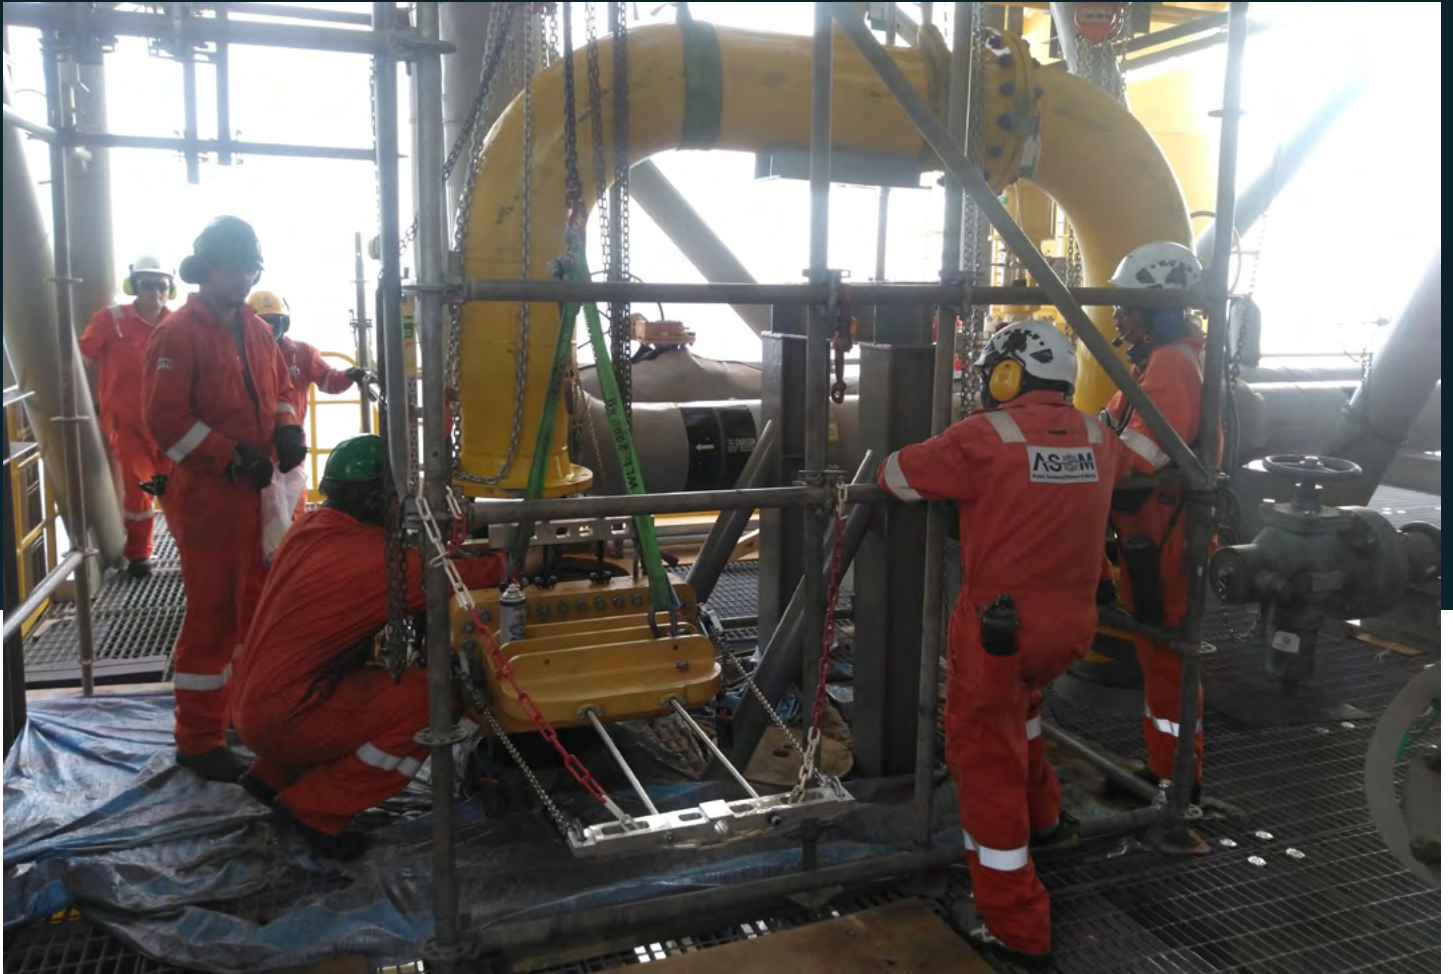
During the planning and feasibility engineering phase of the project, one of the concerns was the GRE to Steel flange – with the potential for damage to the GRE during installation of the AOGV and insertion of the isolation spade. Izomax have previous experience with GRE flange pairs, and GRE to Steel flange pairs, allowing proven design adaptations to be integrated into the design changes required for the project. A modified spade design was accepted and fully tested, whereby rails were integrated to mitigate spade deflection under anticipated flow of up to 630 litres per second (avoiding possible damage to GRE flange faces during insertion). For

the internal testing in the workshop and FAT a customized frame was built and utilised allowing testing with a high flow through spade insertion.

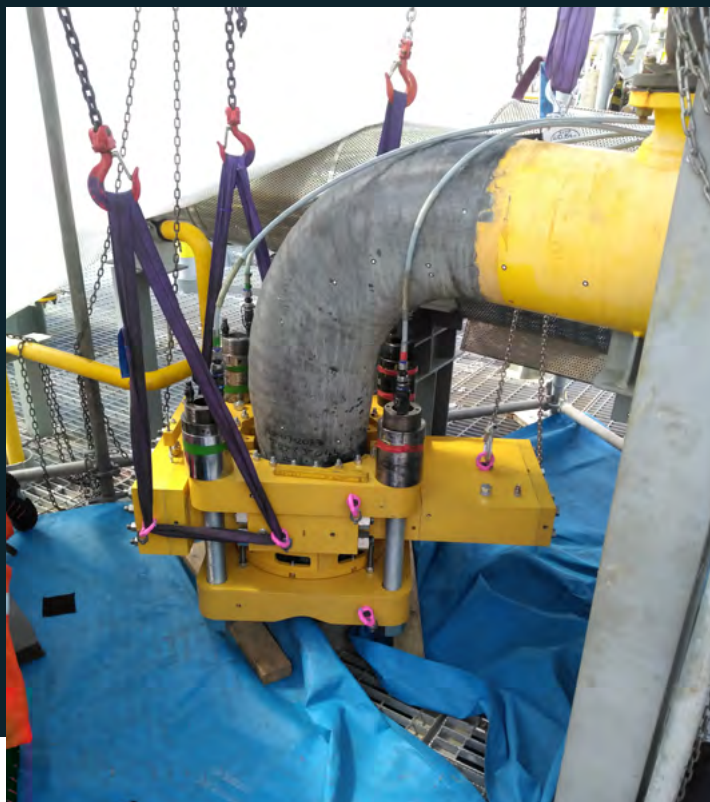
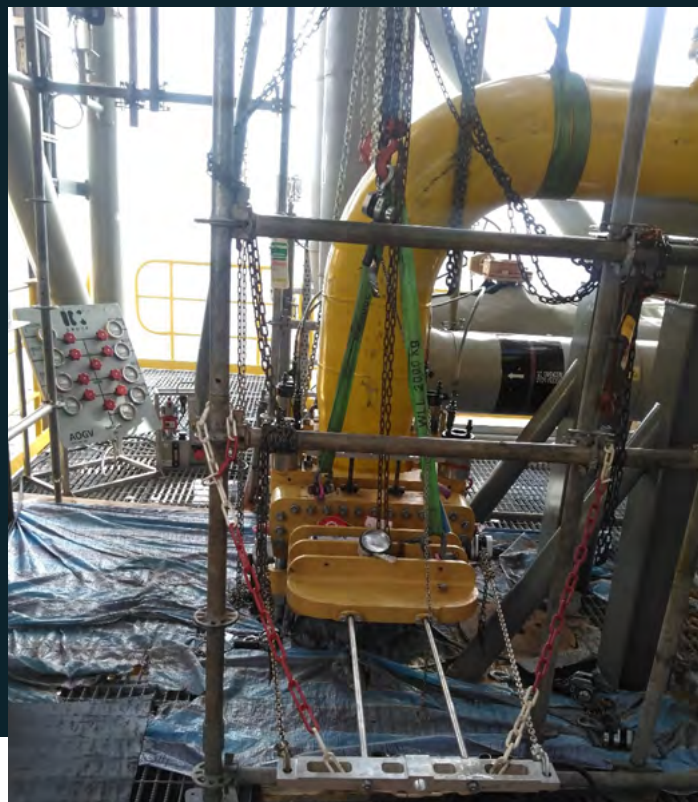
for the 10" piping to be isolated, with estimated (seawater) flow rates of up to 109 litres per second expected. Despite anticipated flow rates, no flow was observed or detected during the operation. Likewise, flow rates of up to 630 litres per second were anticipated during replacement of the two 14" lines – but again, no flow was encountered during the first AOGV operation which gave the operator confidence to utilize the AOGV spade by simply inserting by hand on the second line (saving further time and cost, without compromising safety). System process and full pressure integrity was maintained throughout the operation, with the plant returned

to its original status and condition with 3 new seawater cooling outlet pipes in place.
