AOGV saves time in planned maintenance stop on offshore oil & gas process plant

Offshore pressure vessels need regular maintenance, which is frequently performed during shutdowns, as most are critical to plant production. In this case, three vessels on the FPSO needed attention; two first-stage separators as well as the flare knock out drum.

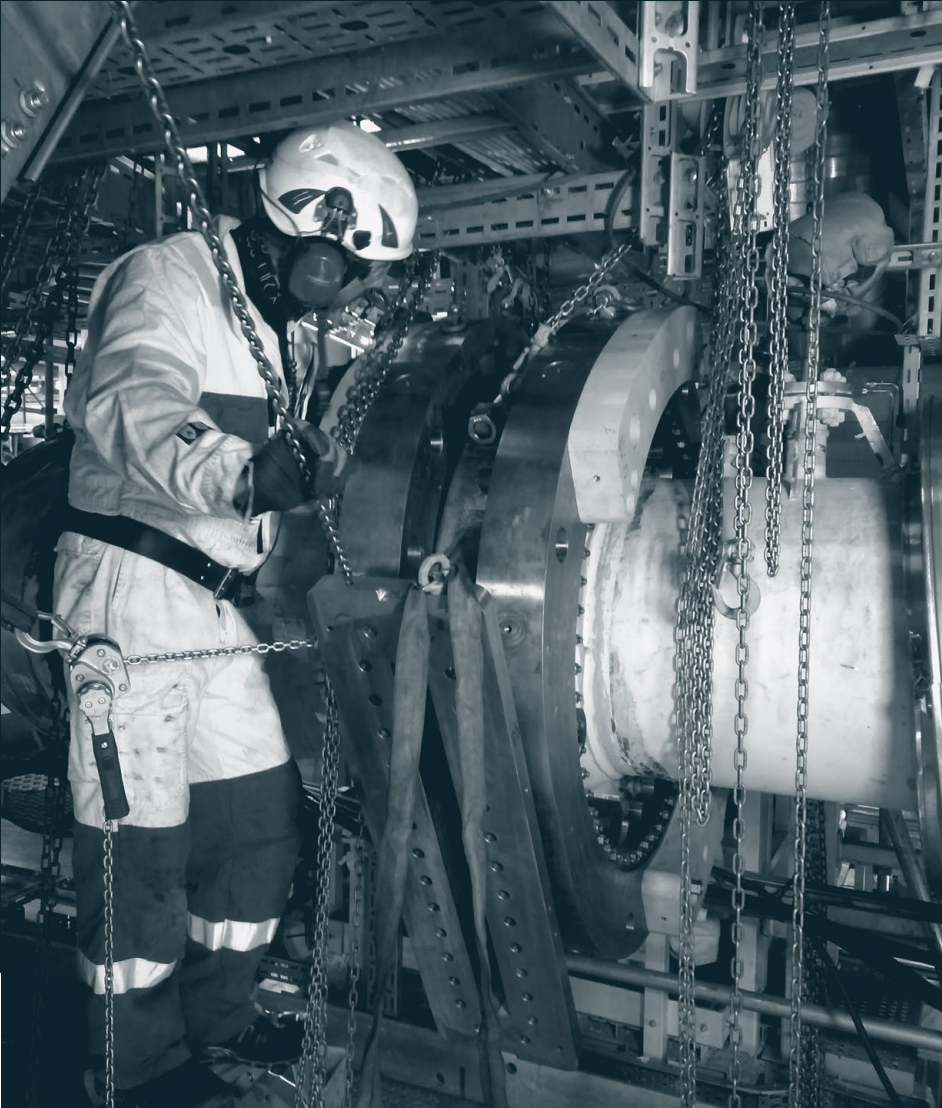
The Izomax patented AOGV is a mechanical isolation tool which can be temporarily assembled on any pair of flanges in a pressurised process system. The tool is used to replace gaskets, install, and retrieve blind spades to facilitate intrusive maintenance. The blind spade or a combination of several spades

in different locations can replace the function of valves and provide positive isolation for vessels, valves, or parts of a process plant. Bleeding or purging through the blind spade can also be facilitated. The AOGV design meets the requirements as per EU Pressure Equipment Directive (PED) (2014/68/ EU) and EN 13445 - Unfired Pressure Vessels.
